A Red Light Running (RLR) Photo Enforcement System was installed at the intersection of US Rte. 34 (Ogden) at S Eola Road on January 8, 2011, after finding limited success with other attempted measures to promote safer driving and improve compliance with traffic laws. The following statistical analysis was performed through 2015. Calendar year 2016 was not included as the Illinois Department of Transportation (IDOT) has not yet completed collecting all data. The statistical analysis will be updated annually, as collected data becomes available from IDOT.

US Rte. 34 (Ogden) at S Eola Road
Aurora, IL

- RLR Photo Enforcement System monitors violations occurring on the east and westbound approaches of the intersection
- RLR Photo Enforcement System installed: January 8, 2011

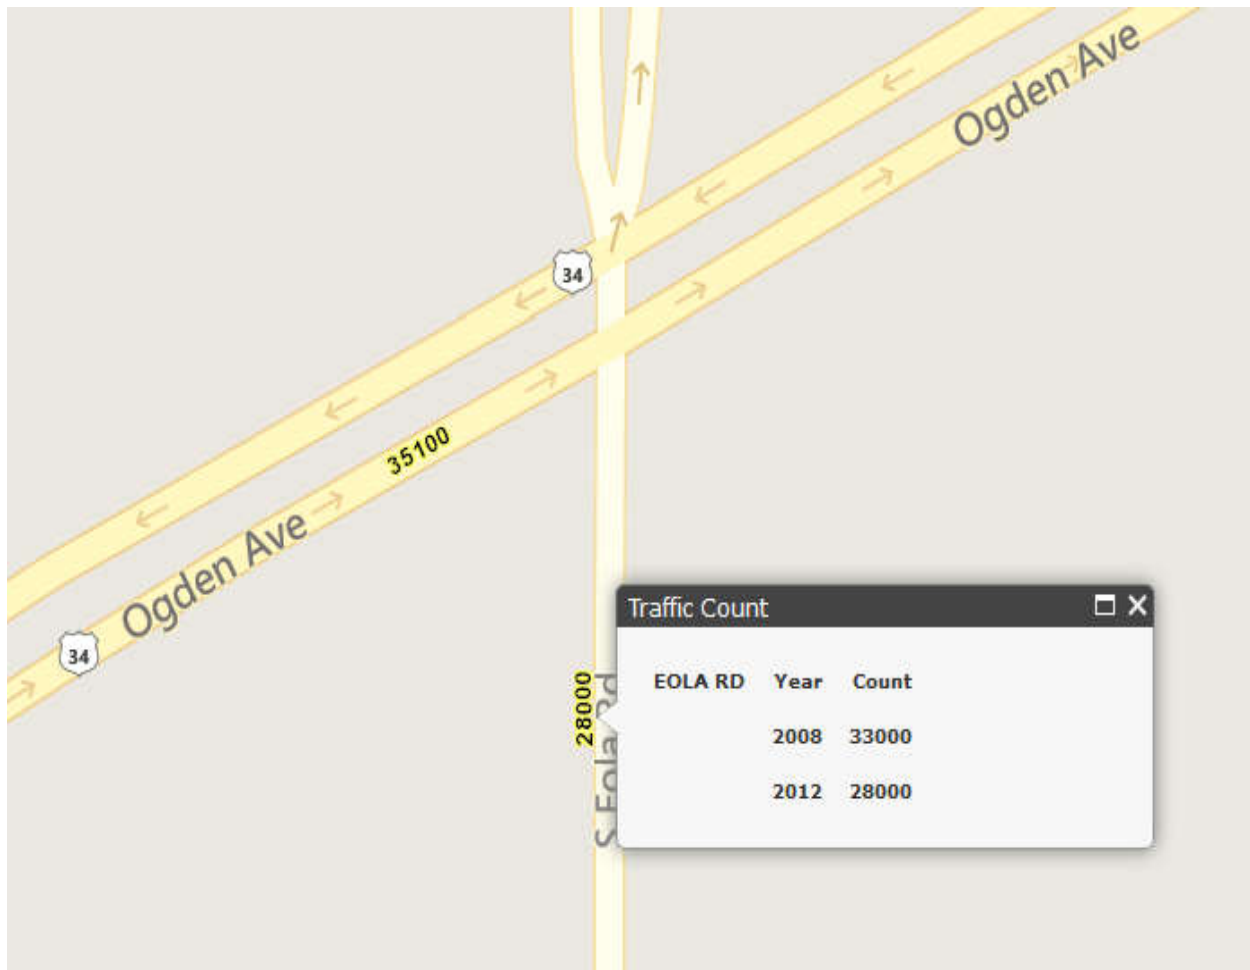
Average Daily Traffic (continued)

S Eola Road (North/Southbound)

- 33,000 (2008)
- 28,000 (2012)
